Critical infrastructure impacts and adaptations in small rural towns following the 2016 Kaikōura earthquake, New Zealand.

A thesis submitted in partial fulfilment of
the requirements for the degree of
Master of Science in Disaster Risk and Resilience
at the University of Canterbury
by
Damon James McKibbin

University of Canterbury

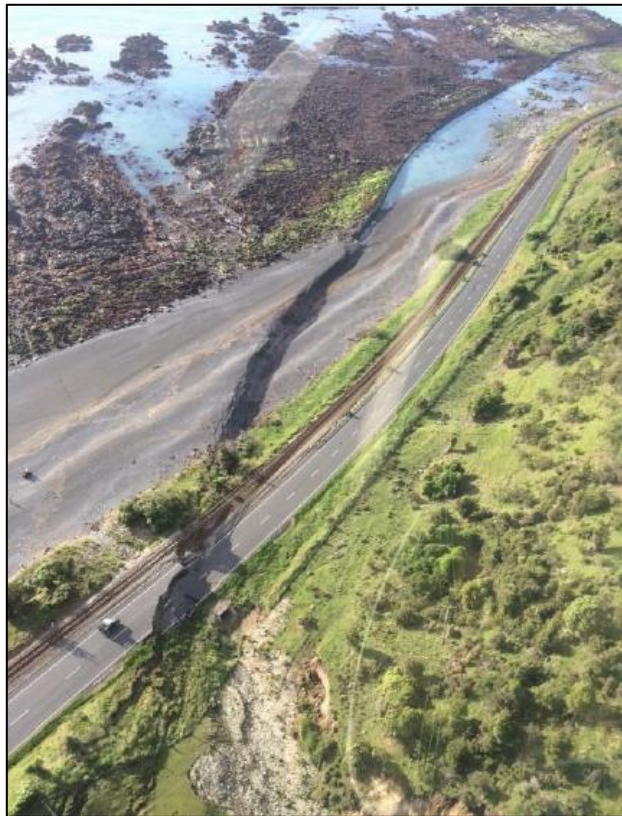
Figure 1.4: Papatea Fault surface rupture across SH1 (Stirling et al., 2017).

More than 30 km of surface rupture has been observed in satellite imagery, with up to 12 m of strike-slip displacement (Hollingsworth, et al., 2017). Surface rupturing has the potential for serious infrastructure disruption (Hollingsworth, et al., 2017), as seen with segments of road and railway which suffered from severe deformation (Figure 1.4)(NCTIR, 2017a).

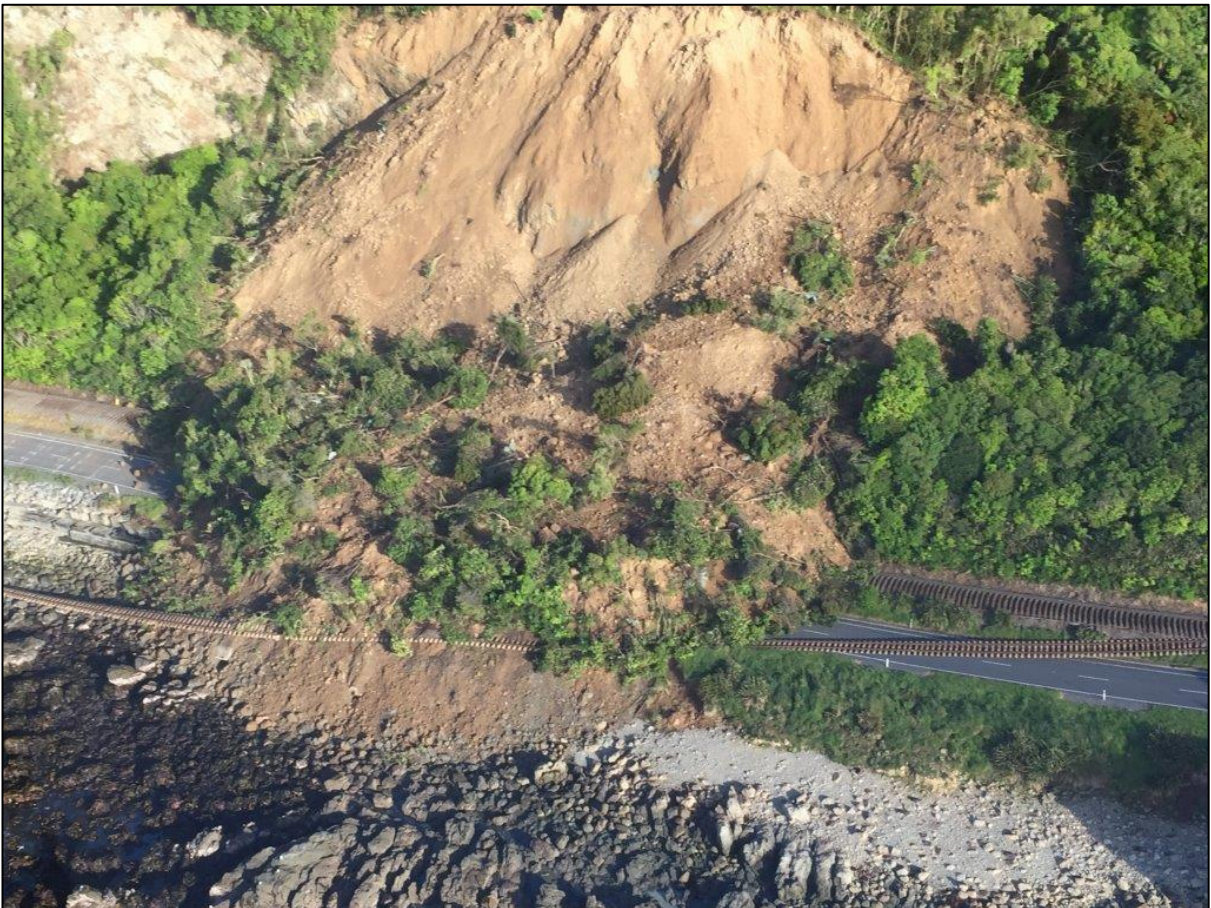
Figure 1.5: Landslide blocking SH1 and pushing Main North Line train tracks off the railroad (Steve Murrin, 2016).

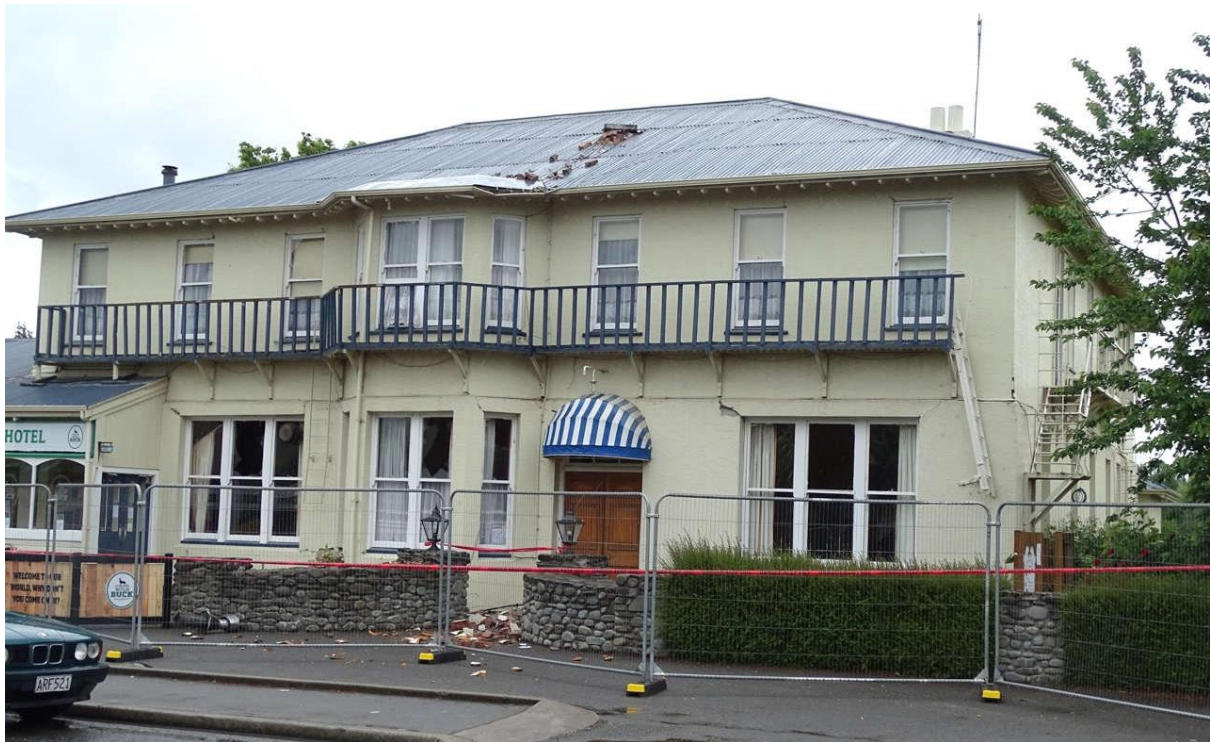
Figure 4.8: Waiau Lodge Hotel, Waiau (D Dizhur and M Giaretton, 2016).

The 107-year-old Waiau Lodge Hotel building and accompanying pub (Figure 4.7, c; Figure 4.8) functioned as an important meeting place for locals before the earthquake. It received a red placard following rapid assessment by HDC. This building was not replaced with an alternative, the Waiau Tavern, for six months. This restricted public gathering to more formal venues such as the school and later the town hall (Figure 4.7, d). Once deemed structurally safe, the town hall was used as a recovery hub instead (see Section 4.2.4 for more details).

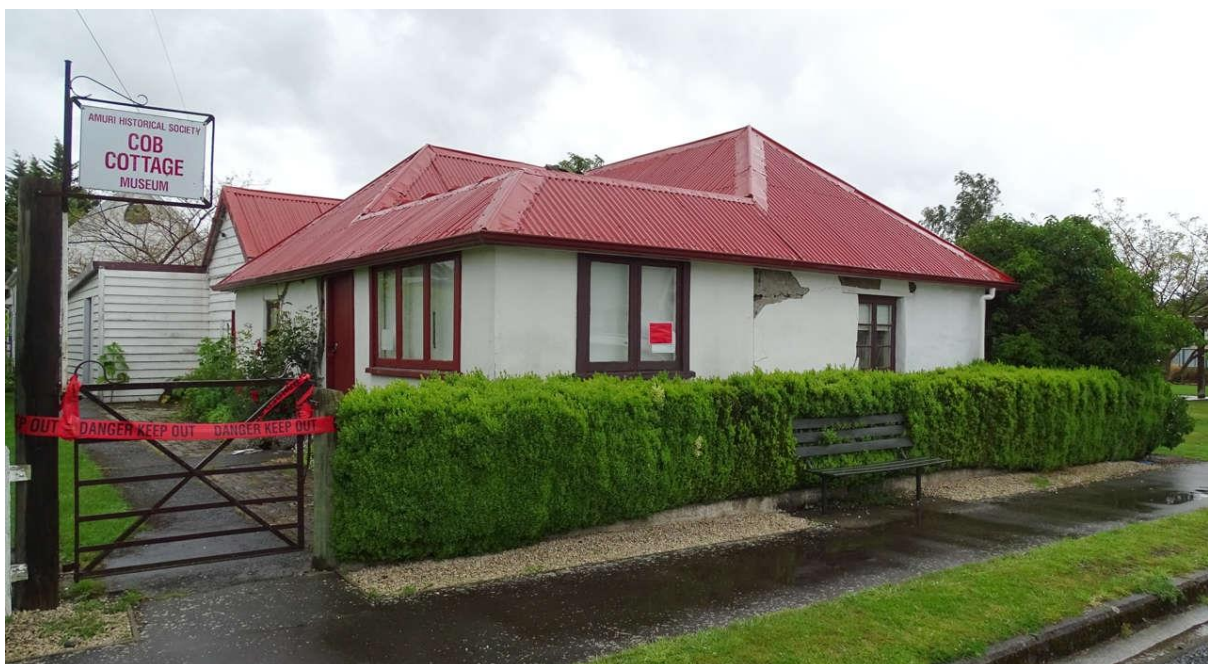
Figure 4.9: Cobb Cottage, Waiau (D Dizhur and M Giaretton, 2016).

The Cobb Cottage was built in the 1860s, and currently operates as a museum housing rural memorabilia (Figure 4.7, e; Figure 4.9). The chimney collapsed with two walls partially collapsing, however the structure is generally intact (Radio NZ, 2018). Exhibitions are now held in a wooden former Presbyterian church on the grounds.

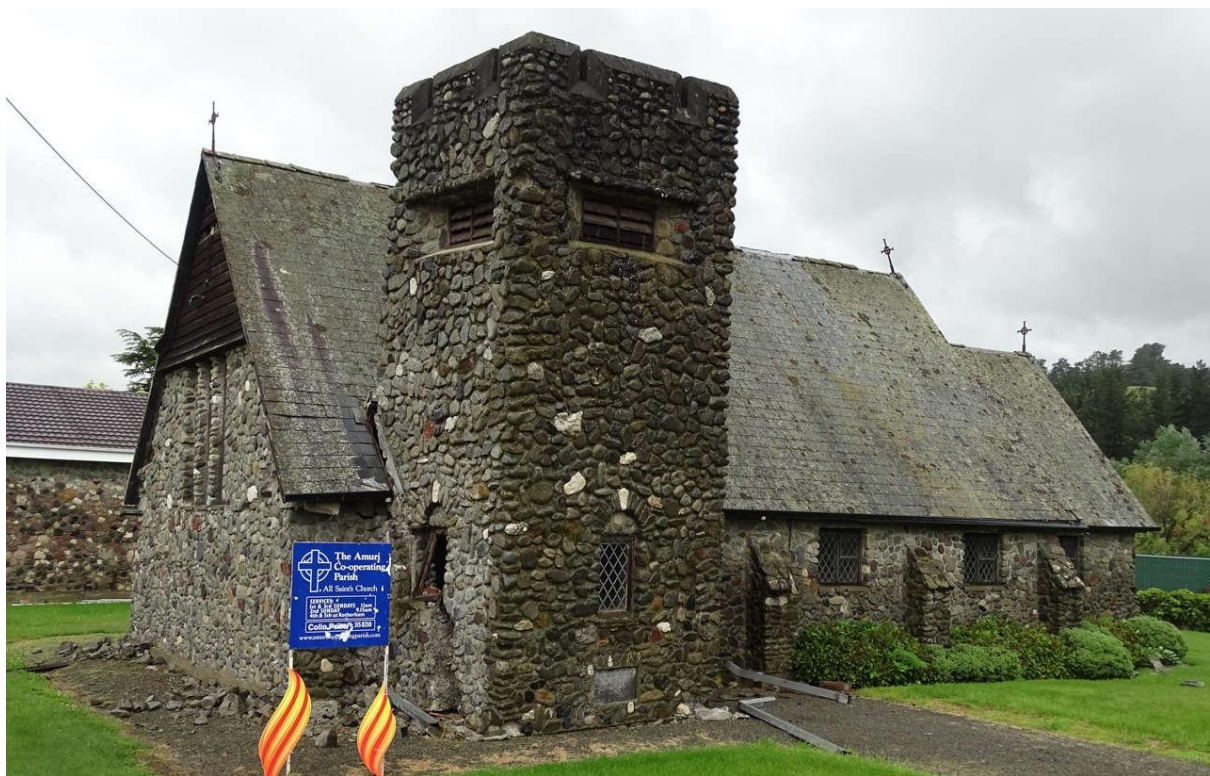
Figure 4.10: All Saints Church, Waiau (D Dizhur and M Giarretton, 2016).

Figure 4.7, f (Figure 4.10) refers to the All Saints joint Anglican-Presbyterian church, which was also given a red placard for damage suffered in the earthquake. While repairs are possible, it would cost an estimated \$1.2 million with no insurance. Until this spiritual centre of Waiau township is restored, church services operate out of the town hall. The two fuel stations in Waiau were unusable until electricity was restored to Waiau. This is due to a common lack of investment in backup generators prior to the earthquake. There was an early reliance on farm stockpiles of fuel as a result, which needed to be carefully rationed.

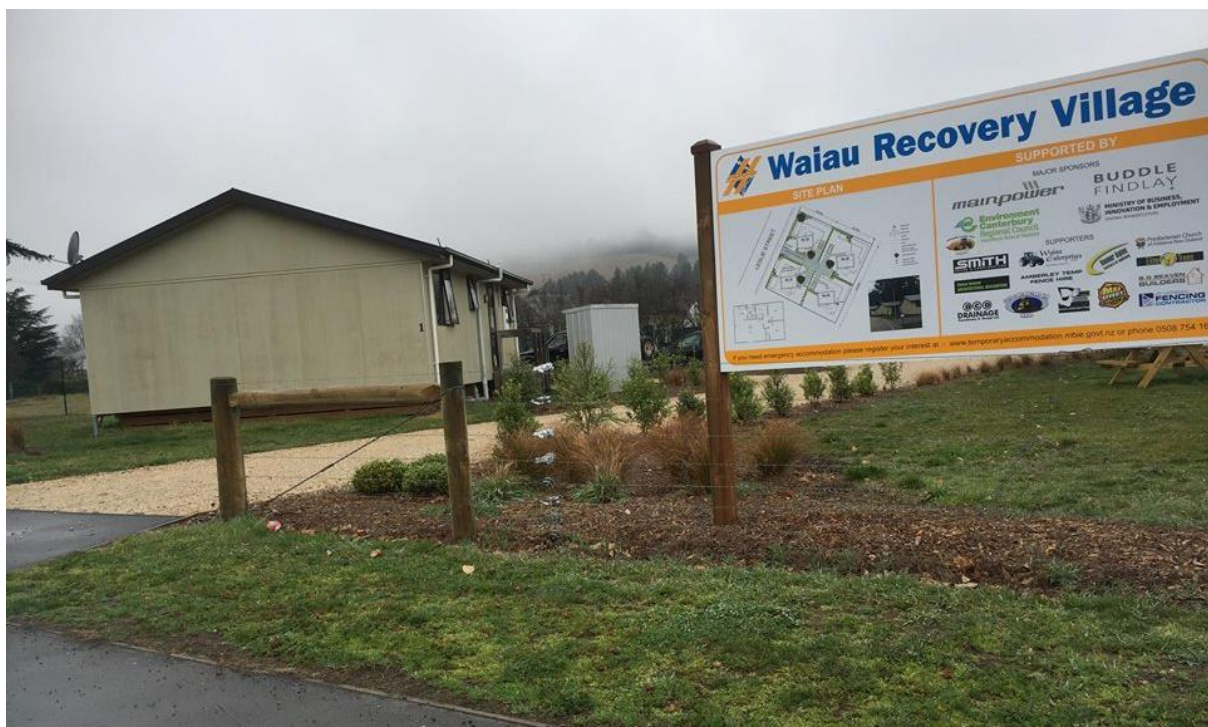
Figure 4.11: Waiau Recovery Village, Waiau (D McKibbin, 2018).

recovery team was established by HDC to help educate people on budgeting, insurance and the process of rebuilding. Temporary accommodation was difficult to find, as rentals and motels had been taken up by non-local contractors and workmen in the recovery phase. To help with this, HDC bought four prefabricated houses from the Minister for Housing and Development at \$25,000 each, with payments deferred until the post-recovery phase. These houses were originally used in a 2011 Christchurch earthquake recovery village. Land for the Waiau recovery village was purchased in the township from church property trustees at market rate, providing a central location for easy accessibility (Figure 4.7, b; Figure 4.11). It took one month to prepare the village and one month building it, with many locals providing labour for free or at a reduced rate.

Despite the attractive concept of a recovery village, uptake was very slow. Two of the houses were left empty for the first six months, and only recently have they all been filled. It is believed that this is due to the late availability of the buildings, as by the time it was opened in July 2017 many displaced people had already found alternative accommodation. These included moving in with friends and relatives, or in some cases establishing themselves in their own garages and sheds. A detracting factor of the recovery village is
